## Boedeker Plastics Case History

### Celazole® U-60 PBI Replaces Metal Valve Stem Bearing in 700°F Gas Turbine Safety Valve Application, Resulting in Significant Uptime.

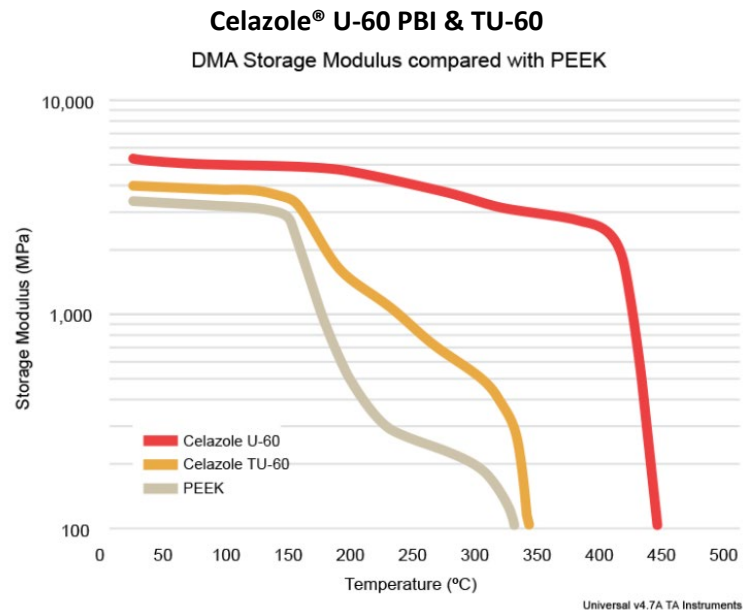
Figure 2 illustrates the dynamic mechanical analysis (DMA) comparing the relative modulus of Celazole® U-60 PBI, Celazole® TU-60 PBI/PEEK Blend, and unfilled PEEK. The DMA data indicates that Celazole® U-60 PBI maintains a high modulus even at 800°F (427°C).

**Figure 2 - DMA Curve**  
Source: PBI Performance Products

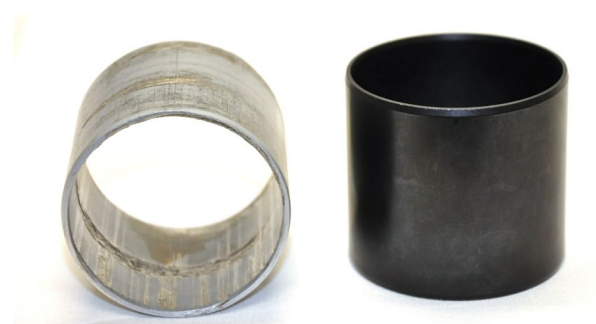
The Celazole® U-60 PBI safety valve stem bearing, illustrated in Figure 3, significantly increased the wear life of the metal bearing from just a few days to over a year. This improvement led to increased uptime, reduced maintenance costs, and enhanced safety, enabling the safety valve to function effectively whenever needed in the gas turbine application.

**Figure 3 – Celazole® U-60 PBI Metal Replacement Bearing**
